Northern Ireland Motorcycle Fatality Report 2012

Indepth Study Of 39 Motorcycle Collisions In Northern Ireland Between
2004 And 2010 In Which 41 Motorcyclists Were Fatally Injured

RIGHT TO RIDE LTD

Elaine Hardy, PhD

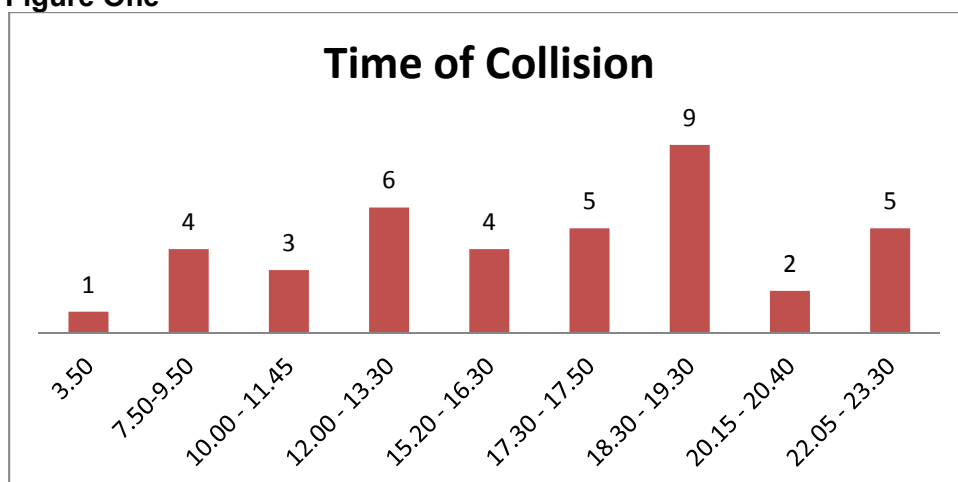
Figure One

The time of day of the collisions highlights that 46.2% (n.18) occurred between afternoon and early evening. 17.9% (n.7) occurred in the evening and 33.3% (n.13) occurred between morning and early afternoon. One collision (2.6%) occurred in the early morning. The highest proportion of fatalities: 23%, (n.9) occurred between 18.30 and 19.30.

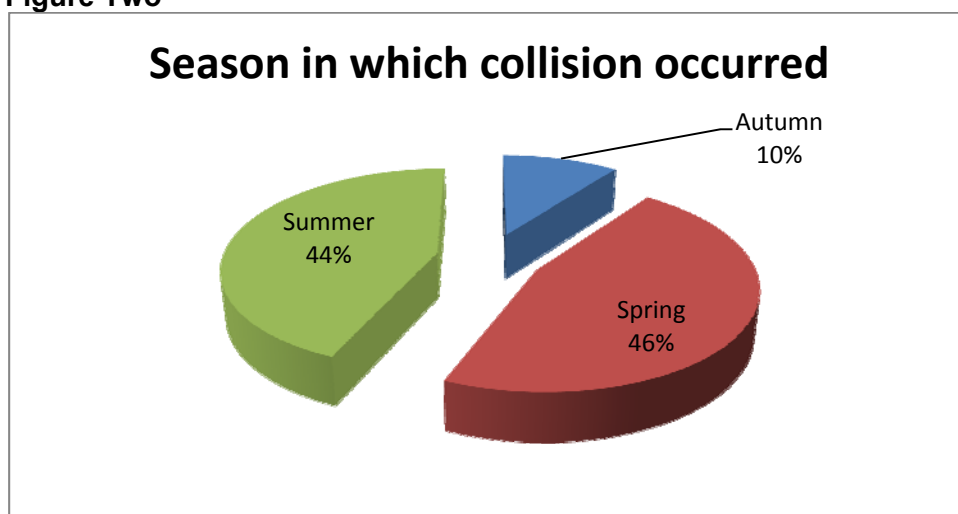
Figure Two

The proportion of collisions occurring in Spring were 46.2% (n.18), Summer 43.6% (n.17) and autumn 10.3% (n.4).

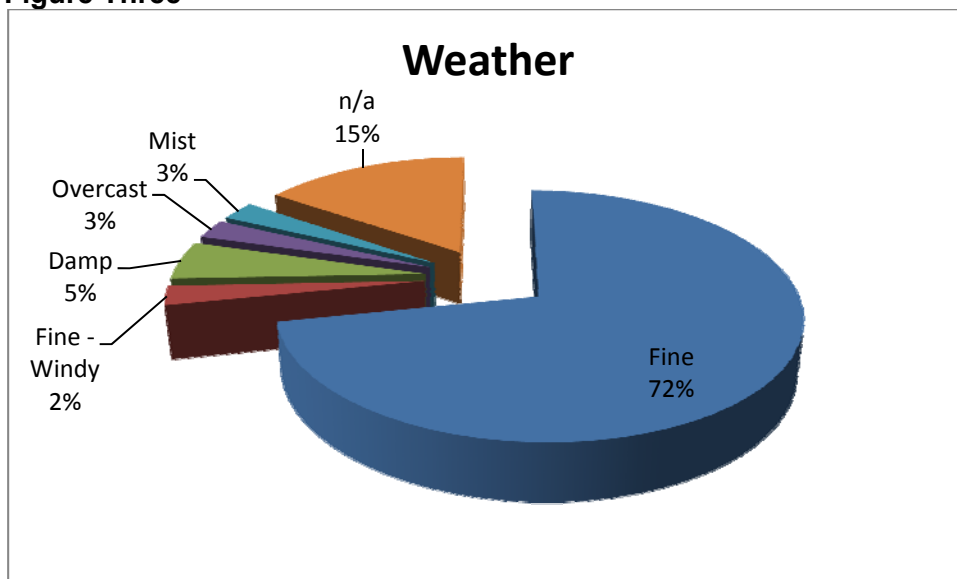
Figure Three

In 72% (n.28) of cases, the weather was fine; in n.4 cases the weather was either overcast or damp. In six cases the weather was not mentioned.

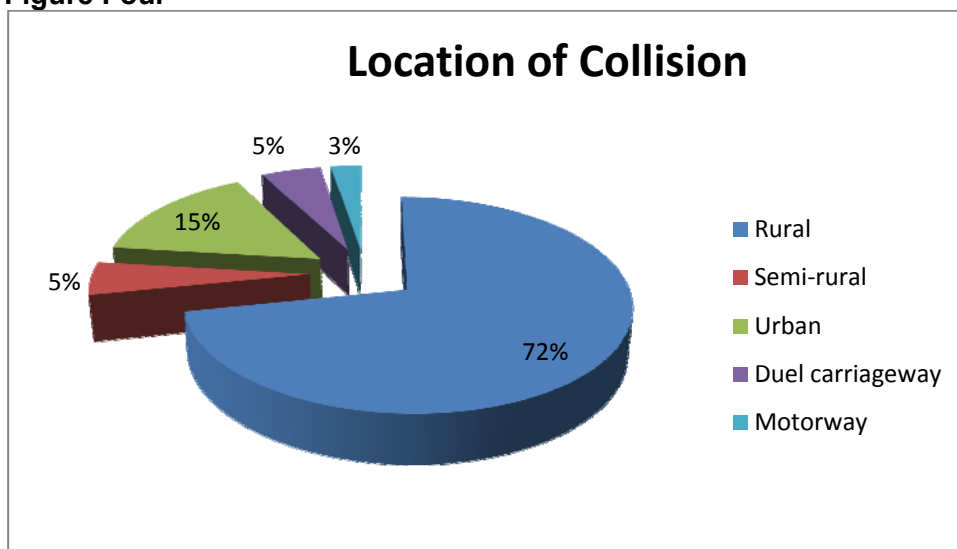
Figure Four

Twenty eight collisions occurred in rural locations (71.8%) while n.6 (15.4%) occurred in urban locations, the remainder occurred in a semi-rural location (n.2), on a duel carriageway (n.2) and one occurred on a motorway.

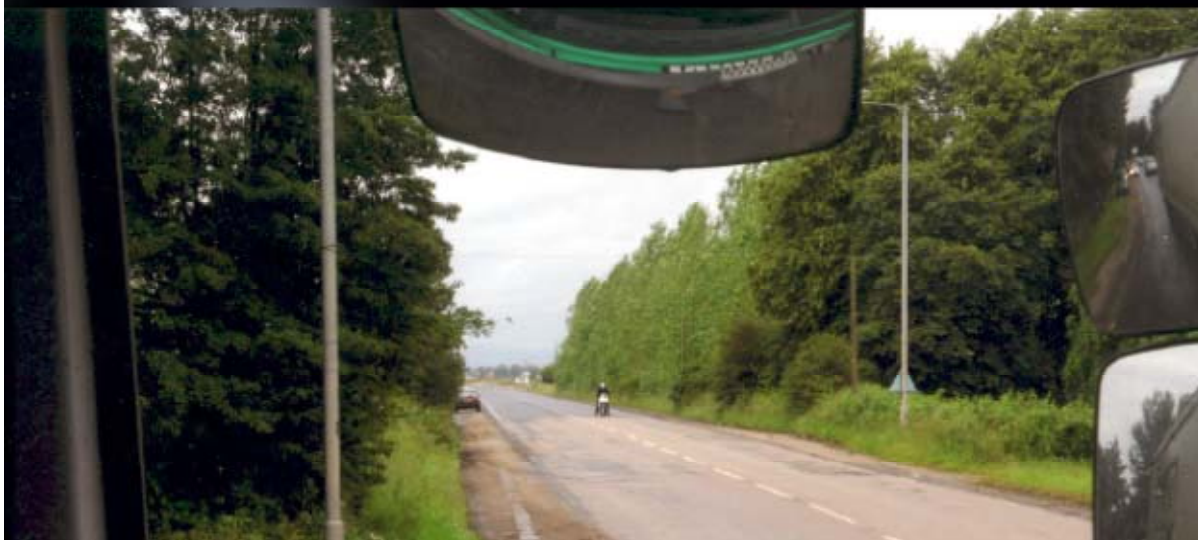
Photograph Three: (perceived a hazard with the motorcycle at a speed of 80 mph)

Below are photographs of the view at 231, 153 and 109 metres. The first indicates the position of the motorcycle when the truck commences to manoeuvre (8 seconds to complete) with the motorcycle at a speed of 80 mph, the second indicates the position of the motorcycle when the truck commences to manoeuvre (8 seconds to complete) with the motorcycle at a speed of 68 mph, the third indicates the position of the motorcycle when the motorcyclist perceived a hazard with the motorcycle at a speed of 80 mph.

VISIBILITY DISTANCE (109m)

The speed at the location of the collision was 40 mph, however according to the investigator the motorcycle had been travelling at a speed of at least 68 to 80 mph at the start of the tyre mark. The Highway Code states that the braking distance at 40 mph is 24 metres. Therefore if braking had been applied at the start of the tyre mark at 40 mph, it should have been possible to stop the motorcycle approx. 31 metres prior to the centre of the junction or 37 metres prior to the collision area.

According to the investigator, the motorcycle was being ridden on dipped beam illumination at the time of the collision, however as shown in the photographs above, the illuminated dipped beam headlight on a similar motorcycle does not significantly alter the visibility of the motorcycle in daylight when viewed from the inside of the truck at the end of the minor road. The illuminated headlight is much more apparent when viewed from a lower angle and when more closely aligned with the direction of travel of the motorcycle (see photograph four below).
